**DEPARTMENT OF TRANSPORTATION**

Contract #: 04-0120F4Cty: SF/ALA Rte: 80 PM: 13.2/13.9File #: 1.28**WELDING INSPECTION REPORT****Resident Engineer:** Casey, William**Address:** 333 Burma Road**City:** Oakland, CA 94607**Report No:** WIR-028414**Date Inspected:** 12-Sep-2012**Project Name:** SAS Superstructure**OSM Arrival Time:** 700**Prime Contractor:** American Bridge/Fluor Enterprises, a JV**OSM Departure Time:** 1930**Contractor:** American Bridge/Fluor Enterprises, a JV**Location:** Job site**CWI Name:** Salvador Merino**CWI Present:** Yes No**Inspected CWI report:** Yes No N/A**Rod Oven in Use:** Yes No N/A**Electrode to specification:** Yes No N/A**Weld Procedures Followed:** Yes No N/A**Qualified Welders:** Yes No N/A**Verified Joint Fit-up:** Yes No N/A**Approved Drawings:** Yes No N/A**Approved WPS:** Yes No N/A**Delayed / Cancelled:** Yes No N/A**Bridge No:** 34-0006**Component:** OBG**Summary of Items Observed:**

Quality Assurance Inspector (QAI) Rodney Patterson was at the American Bridge/Fluor (ABF) job site at Yerba Buena Island in California between the times noted above in order to monitor Quality Control functions and the in process work being performed by ABF

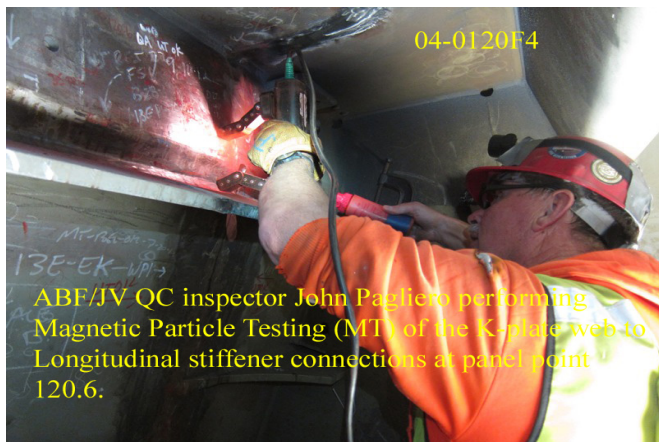
This QA randomly observed ABF/JV QC inspector John Pagliero performing Magnetic Particle Testing (MT) of 13E Deck drop-in longitudinal stiffener splice an K-plate web to Longitudinal stiffener connections at panel point 120.6. The locations tested were in way of repairs performed and completed 48 hours prior. The following locations were tested;

Lift 13E Deck drop-in longitudinal stiffener splice (Weld No. 13E-PP120.6-LS2) The QAI performed a minimum of 15% verification of this weld from face A/B. No rejectable indications were observed at the time of inspection.

Lift 13E K-Plate web to longitudinal stiffener splice (Weld No. 13E-EK-SK1) The QAI performed a minimum of 15% verification of this weld from face A/B. No rejectable indications were observed at the time of inspection.
